**DEPARTMENT OF TRANSPORTATION**

Contract #: 04-0120F4Cty: SF/ALA Rte: 80 PM: 13.2/13.9File #: 69.28**WELDING INSPECTION REPORT****Resident Engineer:**Pursell, Gary**Address:** 333 Burma Road**City:** Oakland, CA 94607**Report No:** WIR-014054**Date Inspected:** 15-May-2010**Project Name:** SAS Superstructure**OSM Arrival Time:** 700**Prime Contractor:** American Bridge/Fluor Enterprises, a JV**OSM Departure Time:** 1900**Contractor:** Zhenhua Port Machinery Company, Ltd (ZPMC), Changxing Island **Location:** Shanghai, China**CWI Name:** Mr. Huang min**CWI Present:** Yes No**Inspected CWI report:** Yes No N/A**Rod Oven in Use:** Yes No N/A**Electrode to specification:** Yes No N/A**Weld Procedures Followed:** Yes No N/A**Qualified Welders:** Yes No N/A**Verified Joint Fit-up:** Yes No N/A**Approved Drawings:** Yes No N/A**Approved WPS:** Yes No N/A**Delayed / Cancelled:** Yes No N/A**Bridge No:** 34-0006**Component:** Orthotropic Box Girder( OBG)**Summary of Items Observed:**

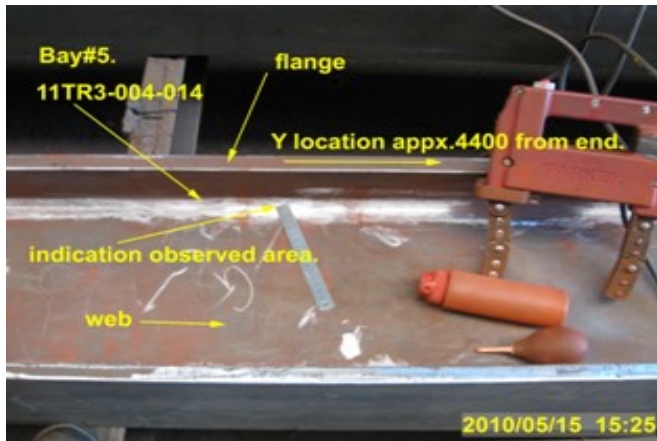
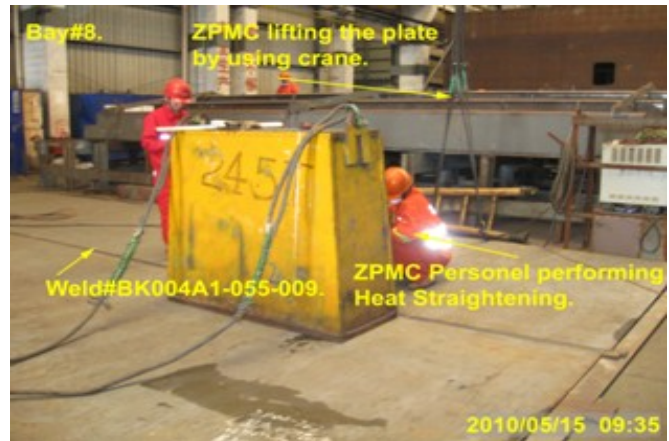
During MT this QA Inspector observed 1 (one) Transverse surface linear indication(Appx.04 mm in length) on weld No:11TR3-004-014.This QA informed to ZPMC QC identified as Cui jun jie and AB/F QA Inspector identified as Mr.Wang wen bin of this issue. The indication has been ground out and MT re tested found to be acceptable.

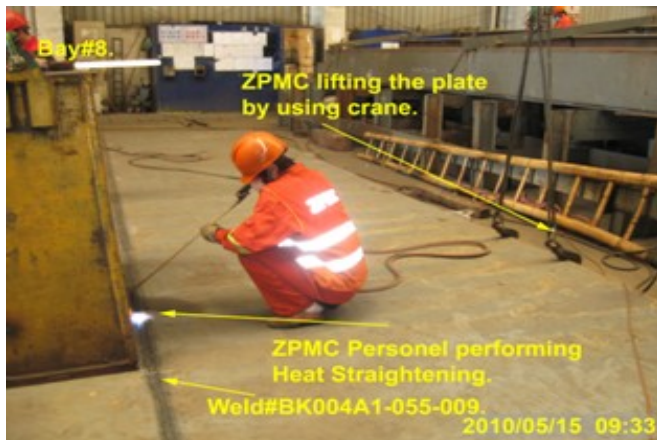
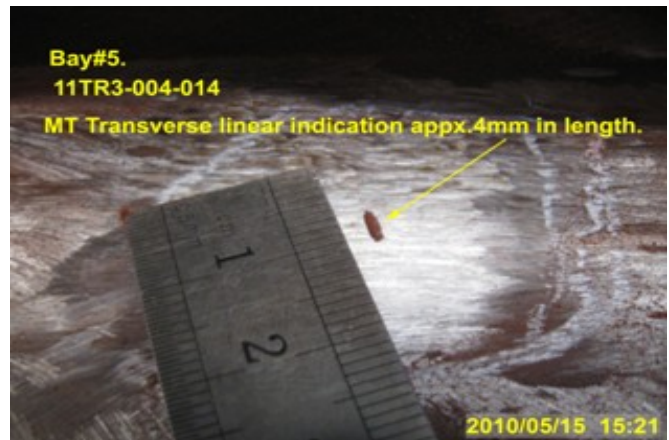
This QA Inspector observed that ZPMC Personnel performing Heat Straightening with using a crane lifting upward with an unknown amount of uplifting force on the Bike Path Deck plate while heating. Heat Straightening was being performed as per the HSR Report#HSR1 (B) 8236. The component and Weld number is identified as BK004A1-055-009.

This QA Informed to ZPMC QC Inspector identified as Mr. Liu Chuan Qang and American Bridge/Fluor QA Inspector Mr. Wang wen bin of the above issue, and reported to Team leader.
